# Certificate of Ventilation System Cleaning

Kitchen extract system cleaned to TR19 Grease specification

The Larkmoor Hotel, 40 Aldwick Parade, Bristol, BS8 1TY

# Kitchen Extraction Post Clean Verification Report

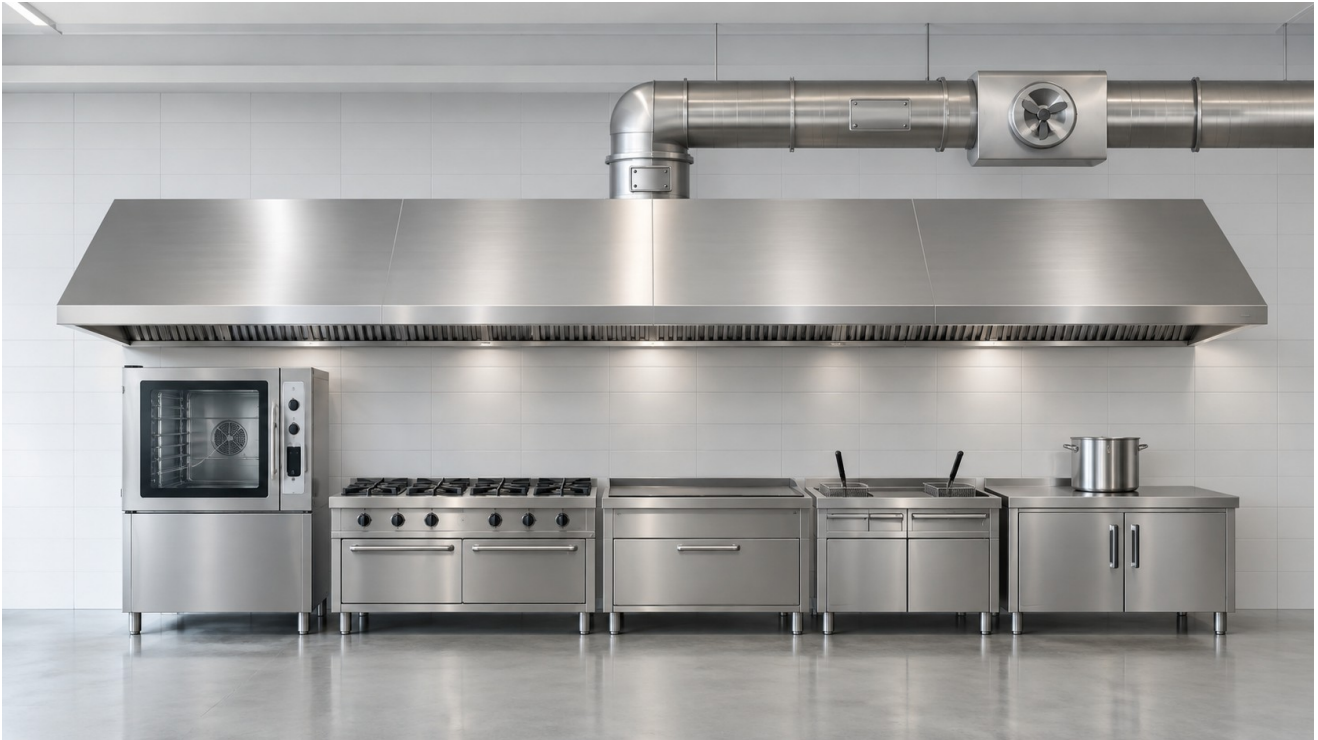
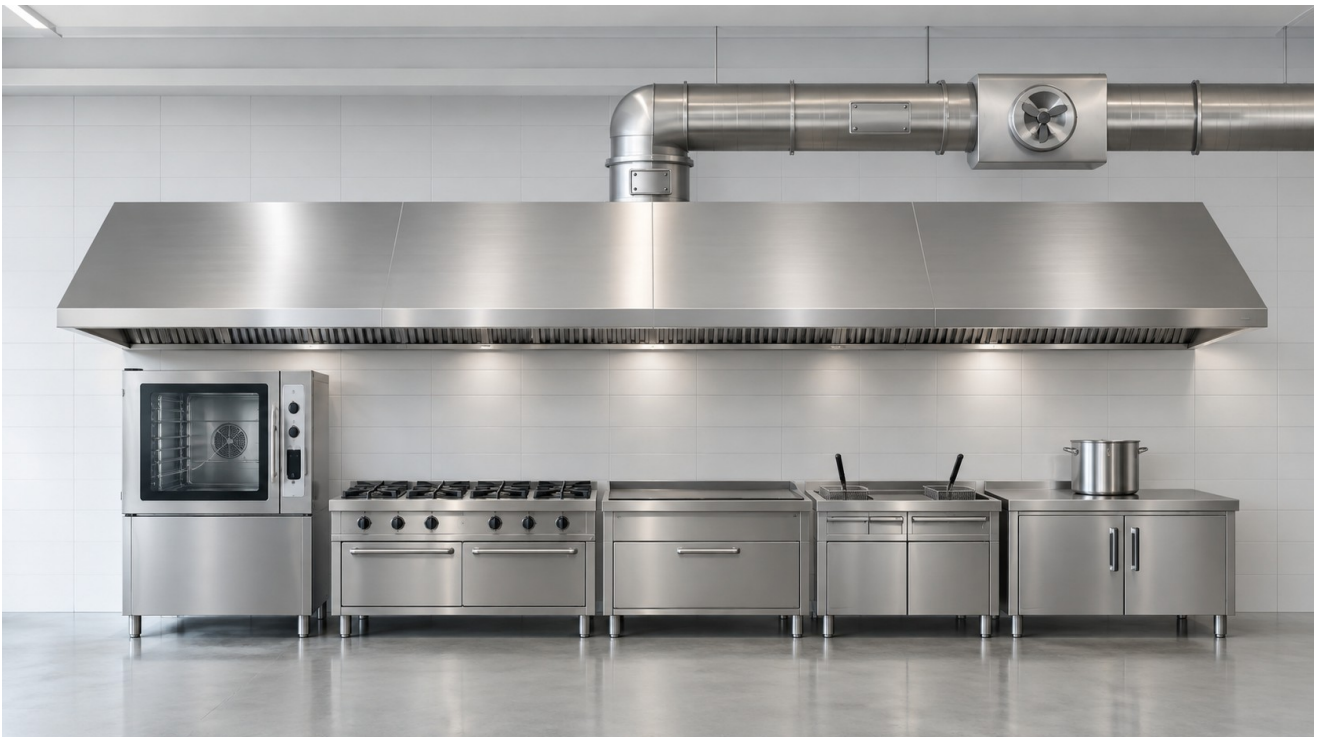
### 1. Canopy (s) / extract plenum (s) / behind filters

| N/A (not applicable) | | Condition Before Cleaning | | | | Condition After Cleaning | |
|---|---|---|---|---|---|---|---|
| Canopy (s) / extract plenum (s) / behind filters | 205 µm | <input type="checkbox"/> | <input checked="" type="checkbox"/> | <input type="checkbox"/> | <input type="checkbox"/> | <input checked="" type="checkbox"/> | 19 µm |

| Photo log locations | Before Clean | After Clean | COMMENTS |
|---|---|---|---|
| 1. Canopy (s) / extract plenum (s) / behind filters | <input checked="" type="checkbox"/> | <input checked="" type="checkbox"/> | |

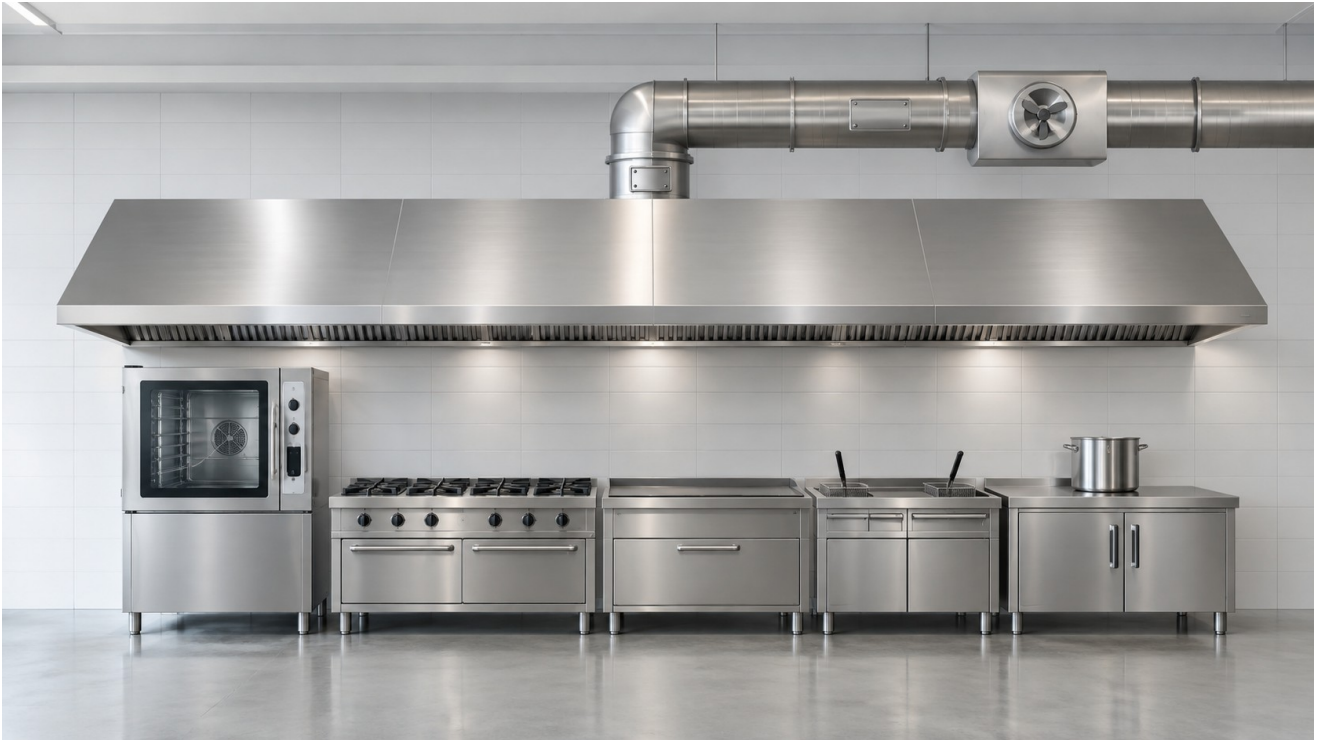
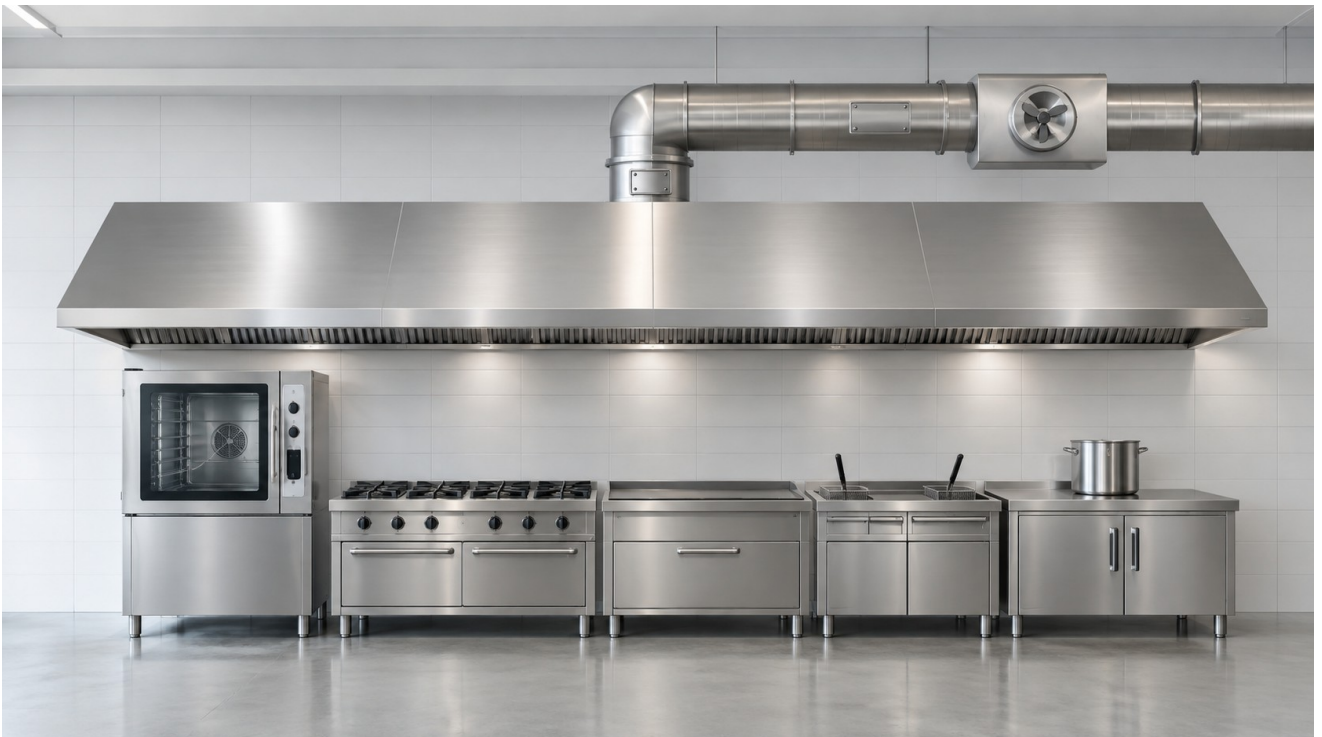
### 2. Grease Filter Housing

| Photo log locations | Before Clean | After Clean | COMMENTS |
|---|---|---|---|
| 2. Grease Filter Housing | <input checked="" type="checkbox"/> | <input checked="" type="checkbox"/> | |

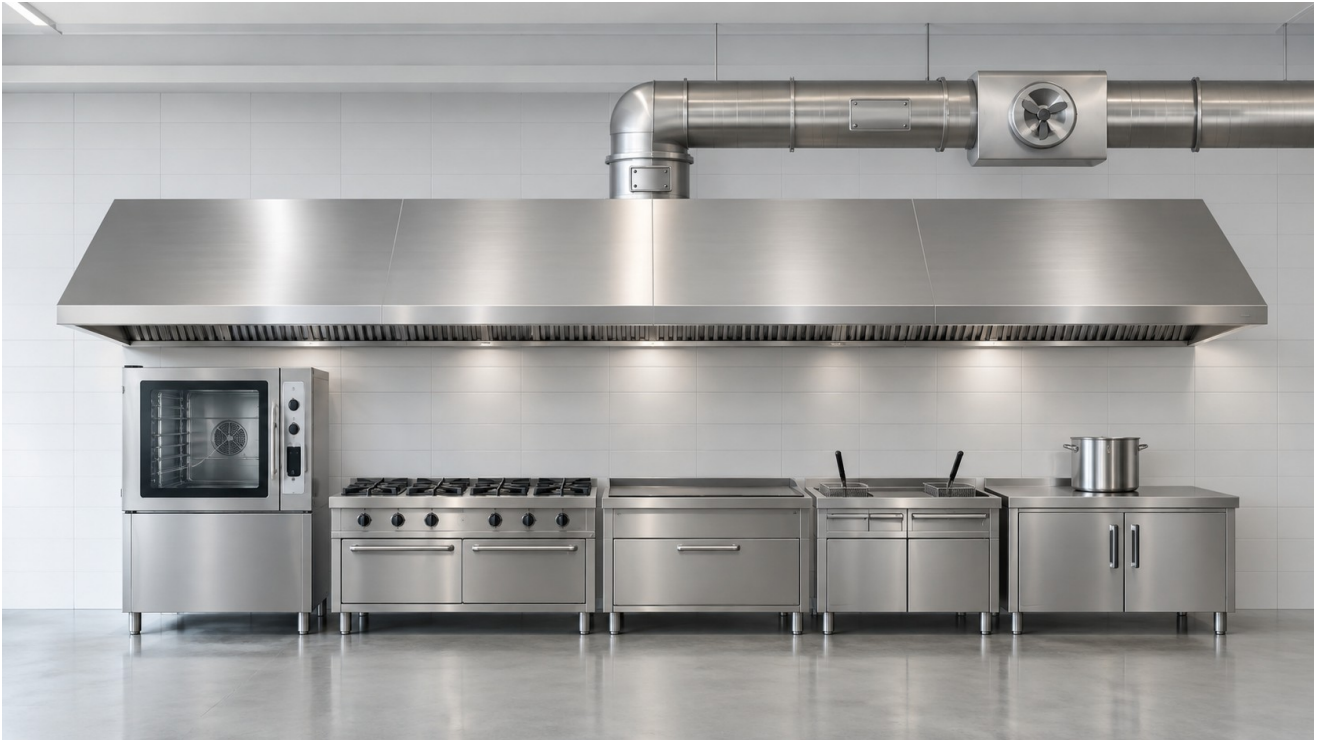
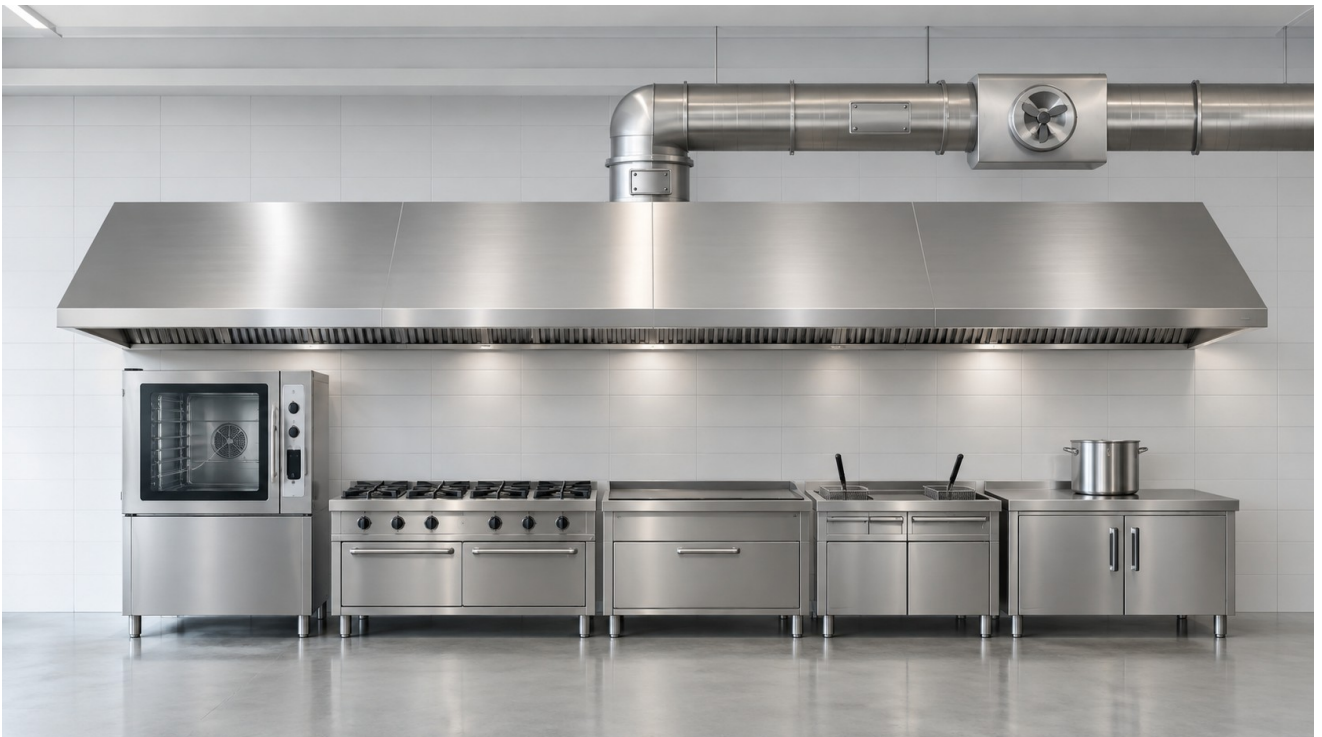
### 3. Grease Filters

| Photo log locations | Before Clean | After Clean | COMMENTS |
|---|---|---|---|
| 3. Grease Filters | <input checked="" type="checkbox"/> | <input checked="" type="checkbox"/> | |

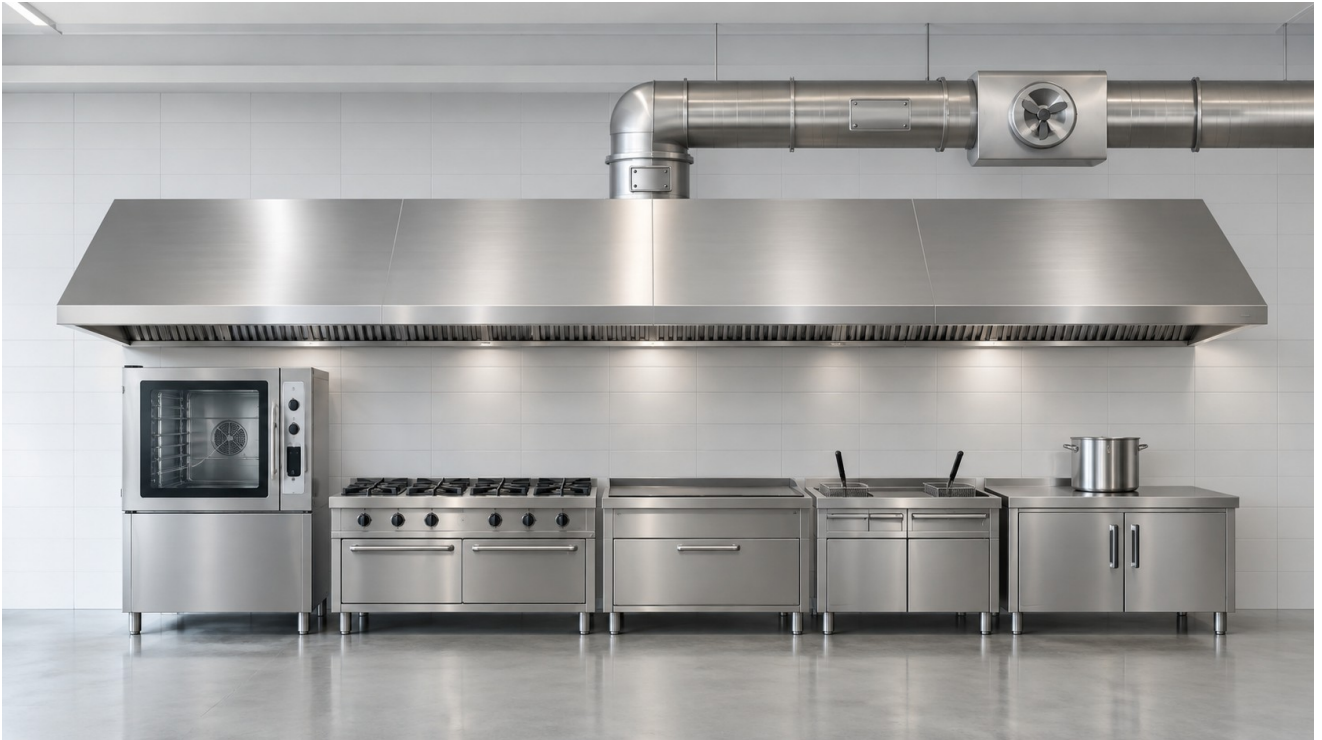
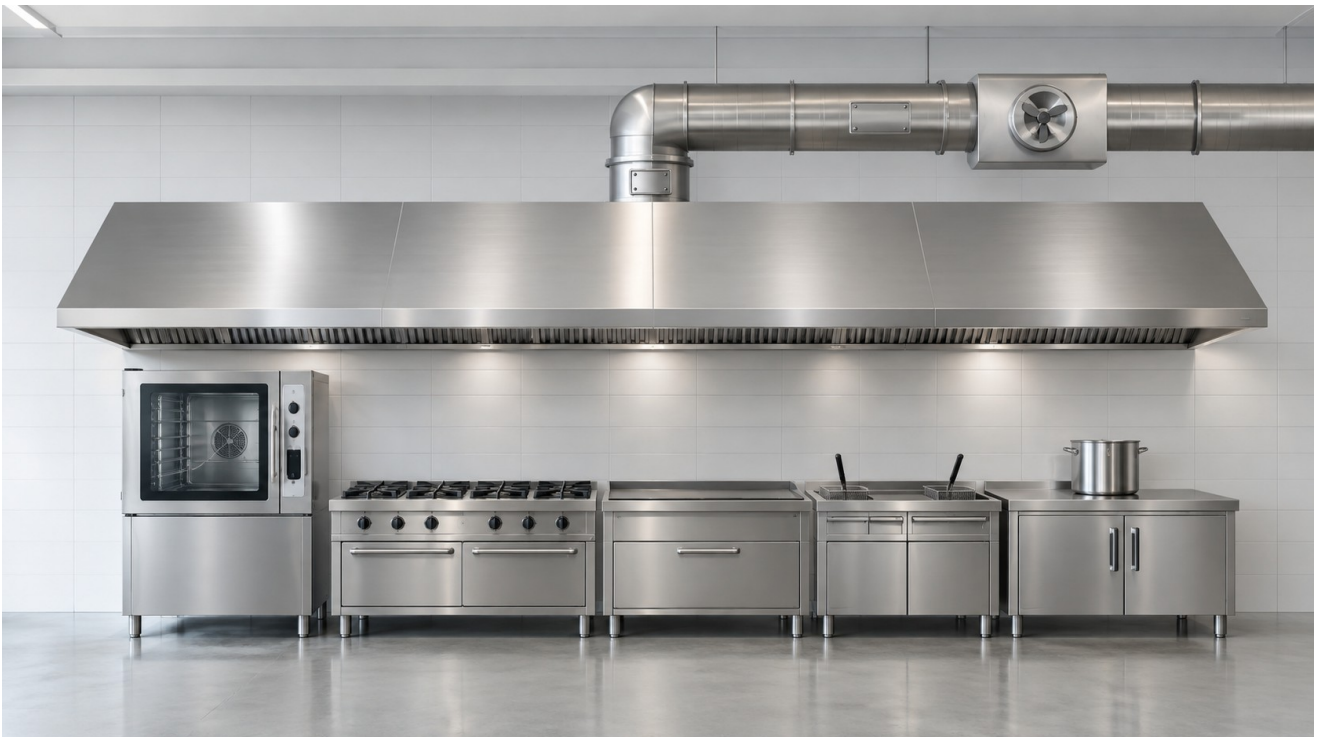
### 4. Duct 1m from canopy

| N/A (not applicable) | | Condition Before Cleaning | | | | Condition After Cleaning | |
|---|---|---|---|---|---|---|---|
| Duct 1m from canopy | 205 µm | <input type="checkbox"/> | <input checked="" type="checkbox"/> | <input type="checkbox"/> | <input type="checkbox"/> | <input checked="" type="checkbox"/> | 19 µm |

| Photo log locations | Before Clean | After Clean | COMMENTS |
|---|---|---|---|
| 4. Duct 1m from canopy | <input checked="" type="checkbox"/> | <input checked="" type="checkbox"/> | |

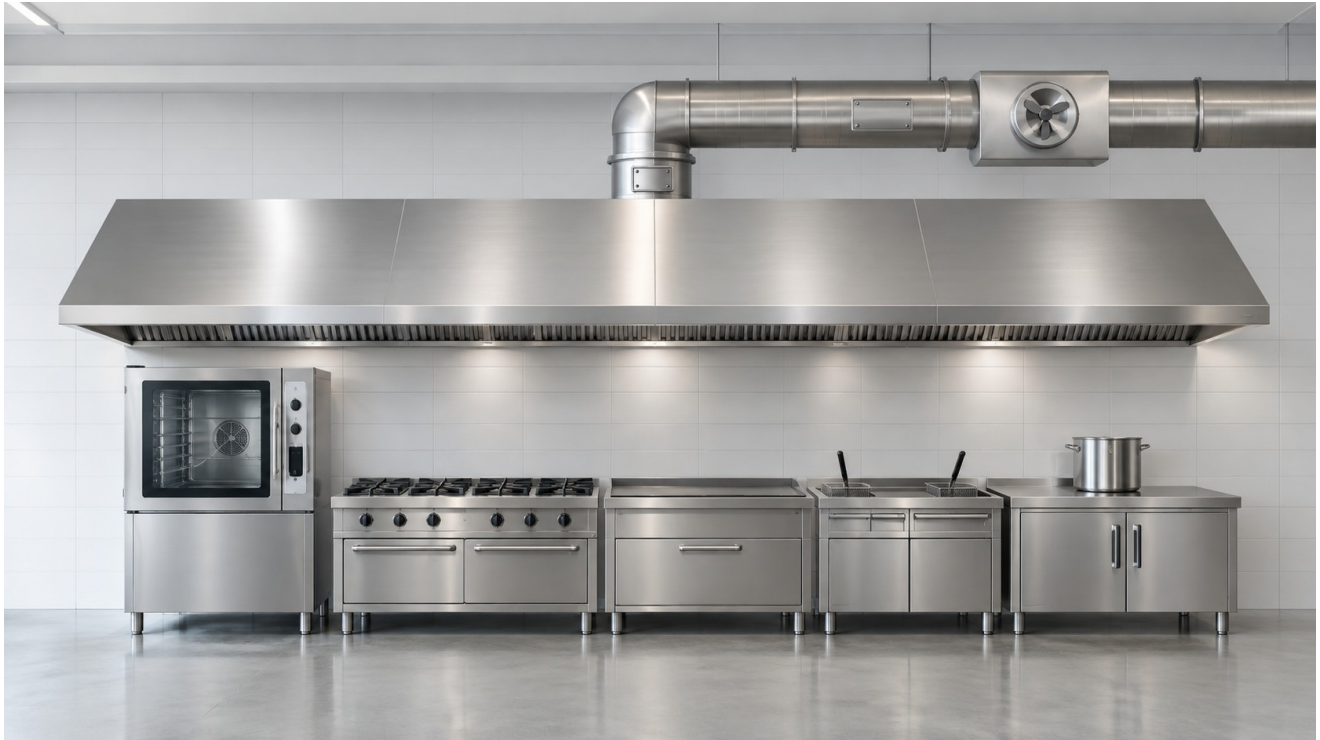
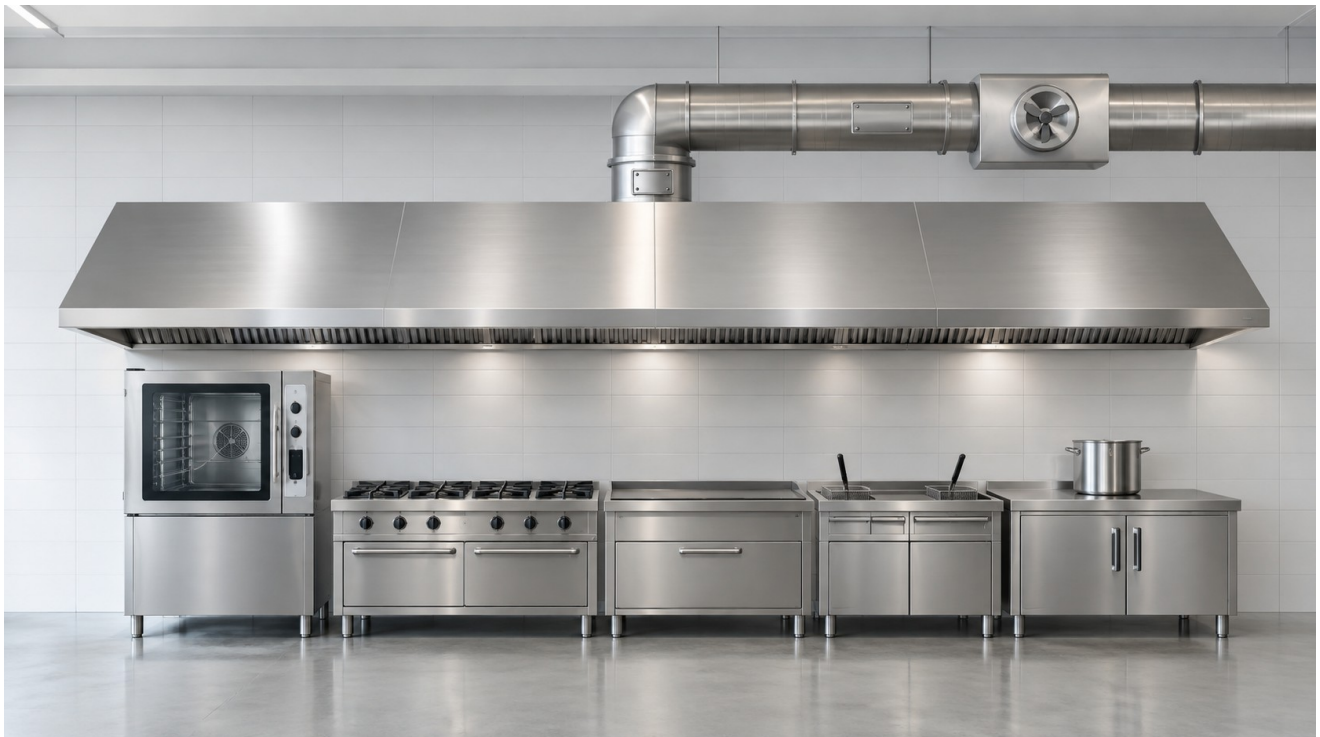
### 5. Duct 3m from canopy

| N/A (not applicable) | | Condition Before Cleaning | | | | Condition After Cleaning | |
|---|---|---|---|---|---|---|---|
| Duct 3m from canopy | 205 µm | <input type="checkbox"/> | <input checked="" type="checkbox"/> | <input type="checkbox"/> | <input type="checkbox"/> | <input checked="" type="checkbox"/> | 19 µm |

| Photo log locations | Before Clean | After Clean | COMMENTS |
|---|---|---|---|
| 5. Duct 3m from canopy | <input checked="" type="checkbox"/> | <input checked="" type="checkbox"/> | |

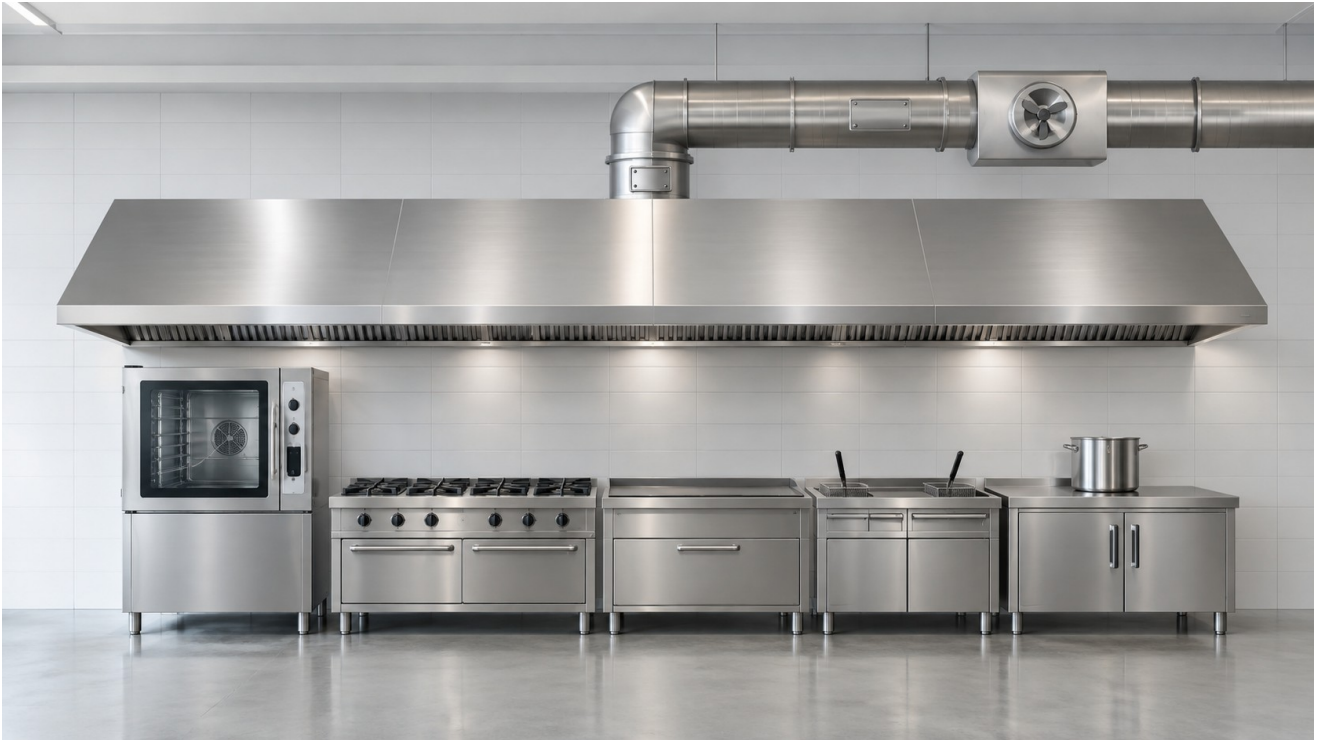
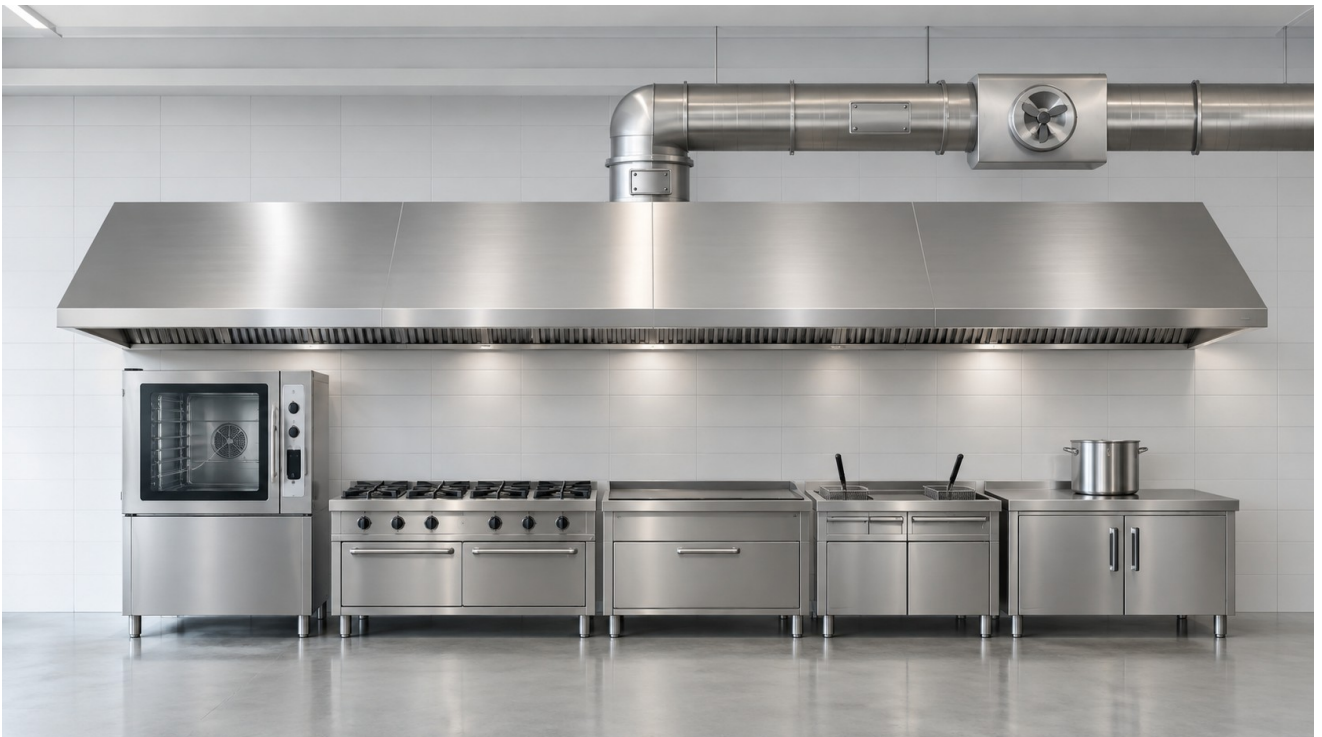
### 6. Duct midway between canopy (s) and fan

| N/A (not applicable) | | Condition Before Cleaning | | | | Condition After Cleaning | |
|---|---|---|---|---|---|---|---|
| Duct midway between canopy (s) and fan | 205 µm | <input type="checkbox"/> | <input checked="" type="checkbox"/> | <input type="checkbox"/> | <input type="checkbox"/> | <input checked="" type="checkbox"/> | 19 µm |

| Photo log locations | Before Clean | After Clean | COMMENTS |
|---|---|---|---|
| 6. Duct midway between canopy (s) and fan | <input checked="" type="checkbox"/> | <input checked="" type="checkbox"/> | |

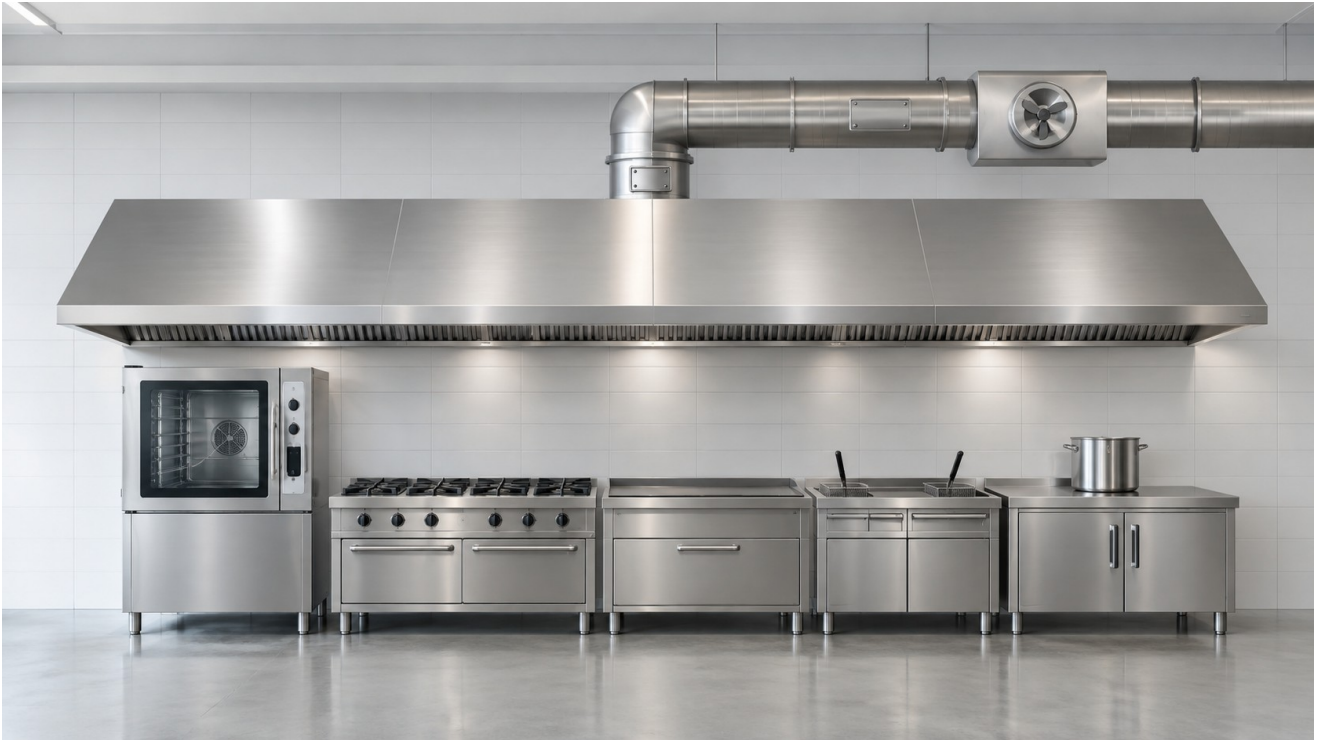
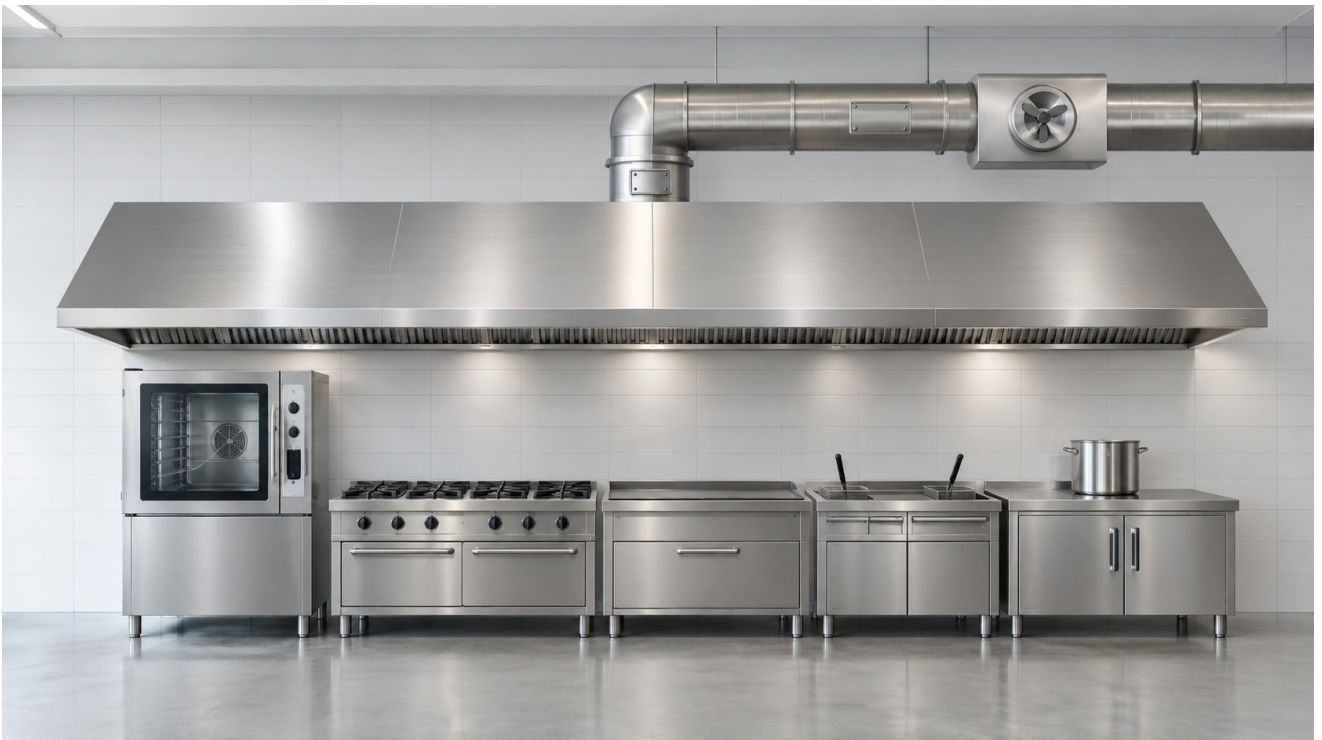
### 7. Fan

| N/A (not applicable) | | Condition Before Cleaning | | | | Condition After Cleaning | |
|---|---|---|---|---|---|---|---|
| Fan | 205 µm | <input type="checkbox"/> | <input checked="" type="checkbox"/> | <input type="checkbox"/> | <input type="checkbox"/> | <input checked="" type="checkbox"/> | 19 µm |

| Photo log locations | Before Clean | After Clean | COMMENTS |
|---|---|---|---|
| 7. Fan | <input checked="" type="checkbox"/> | <input checked="" type="checkbox"/> | |

| Frequency of control clean | Daily micron average accumulation range |
|---|---|
| First visit. Two canopy sections and a long roof run; all locations reached. Grease trap at the fan drained. | |

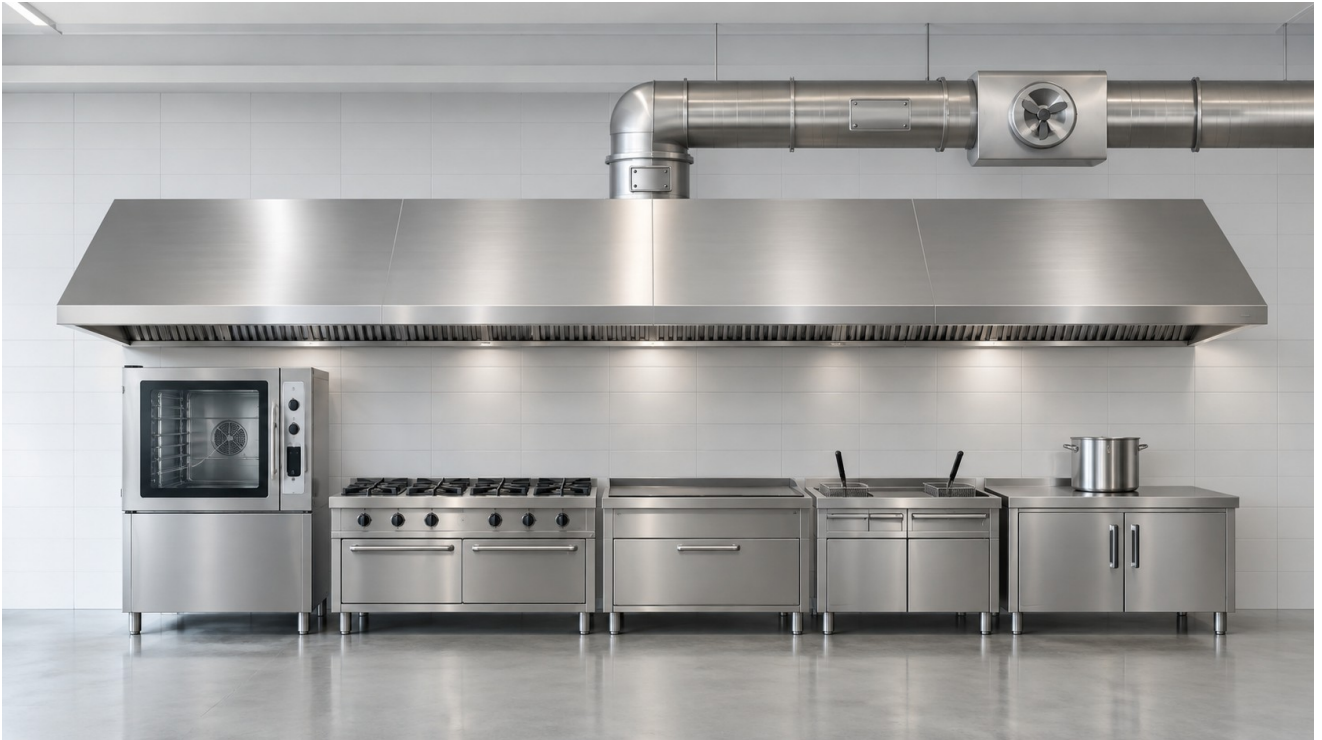
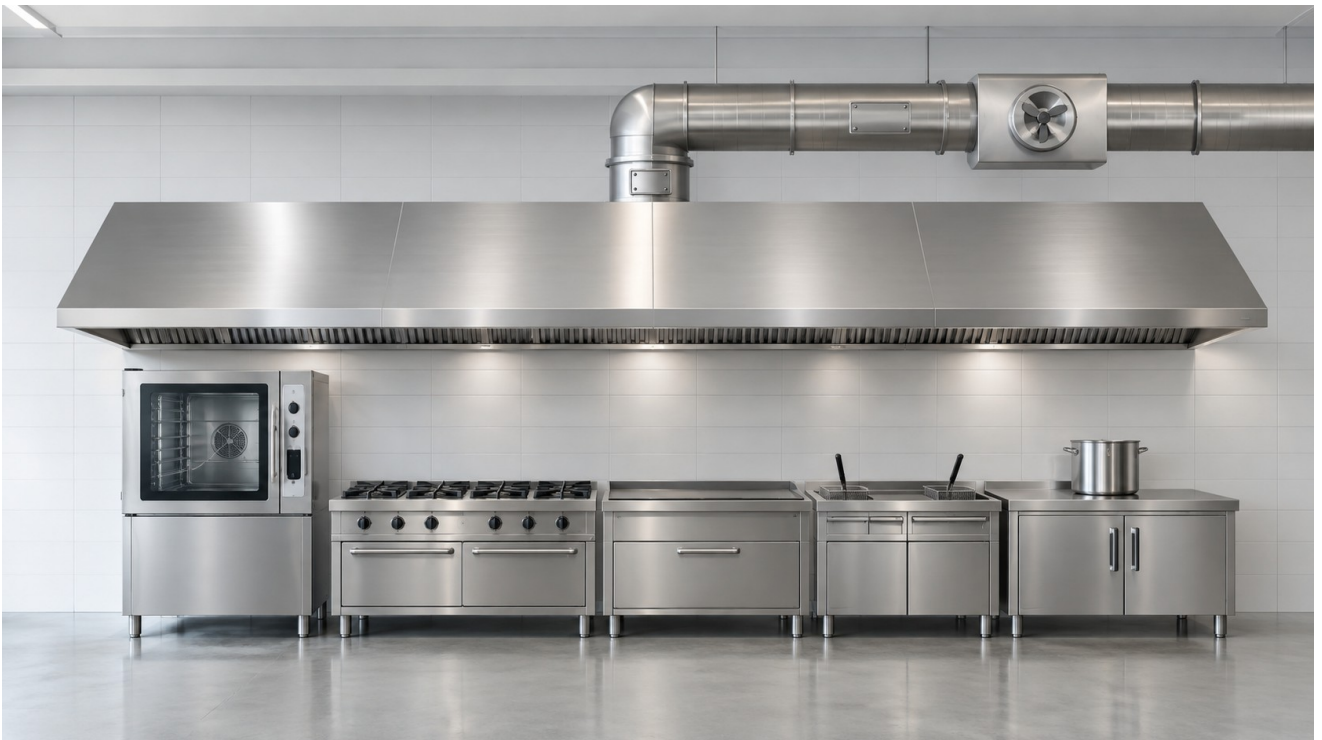
### 8. Discharge Ductwork

| N/A (not applicable) | | Condition Before Cleaning | | | | Condition After Cleaning | |
|---|---|---|---|---|---|---|---|
| Discharge Ductwork downstream fan | 205 µm | <input type="checkbox"/> | <input checked="" type="checkbox"/> | <input type="checkbox"/> | <input type="checkbox"/> | <input checked="" type="checkbox"/> | 19 µm |

| Photo log locations | Before Clean | After Clean | COMMENTS |
|---|---|---|---|
| 8. Discharge Ductwork | <input checked="" type="checkbox"/> | <input checked="" type="checkbox"/> | |

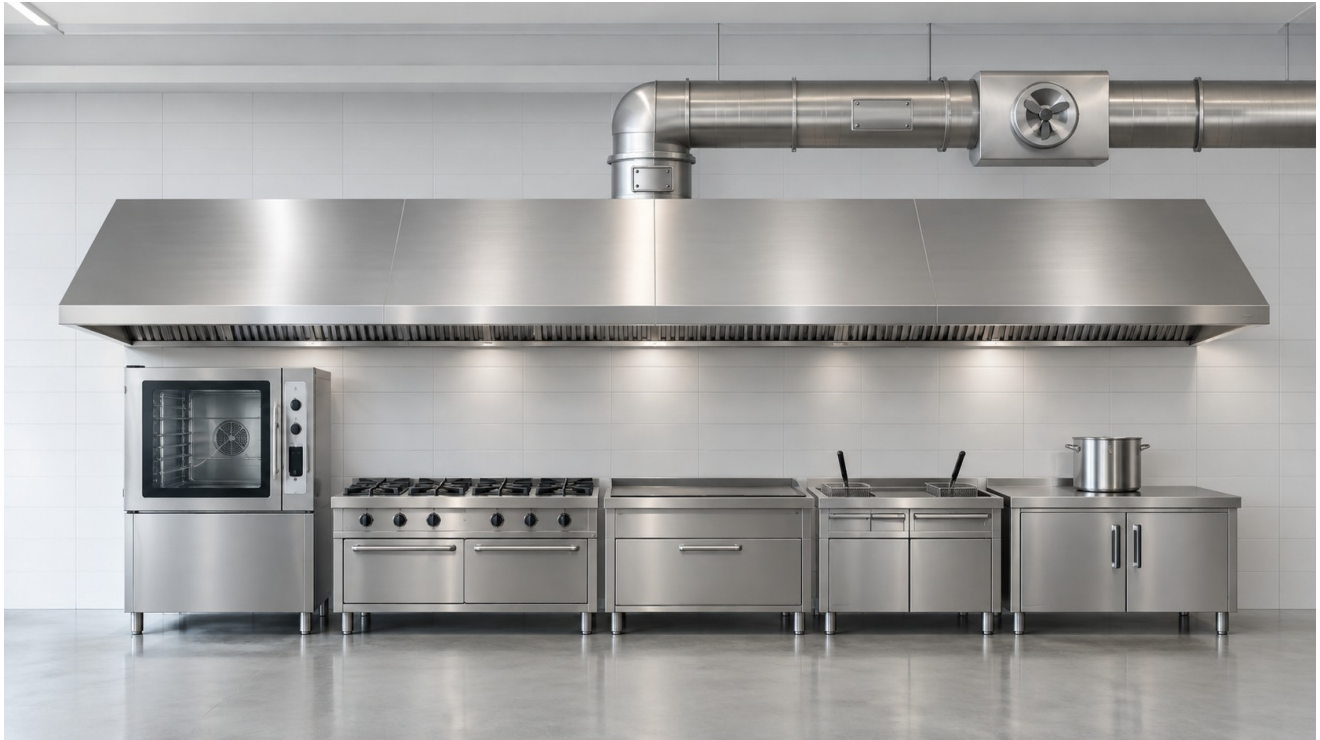
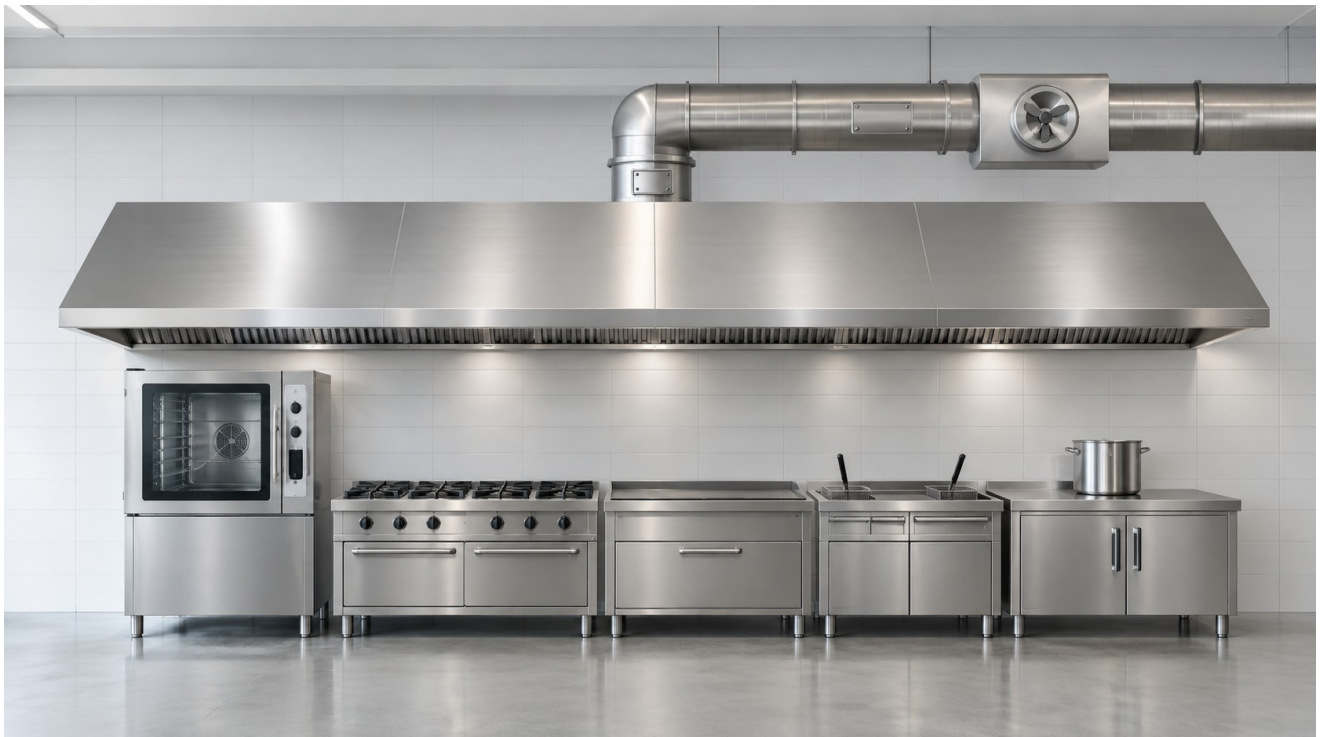
### 9. Discharge Cap/Hood

| Photo log locations | Before Clean | After Clean | COMMENTS |
|---|---|---|---|
| 9. Discharge Cap/Hood | <input checked="" type="checkbox"/> | <input checked="" type="checkbox"/> | |
